TRIANGULAR WAVE Fact Sheet

TRIANGULAR WAVE SYSTEM PROTECTS ENTIRE KESSLER'S INC. MEAT PROCESSING PLANT FROM DEPOSITS AND CORROSION IN THE WATER SYSTEM

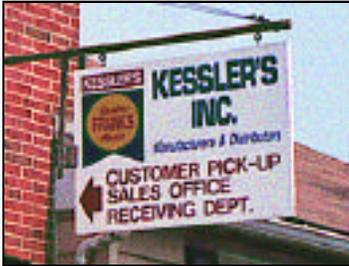
Kessler's Inc. had a major water problem. The scale in the water coming to their plant was so bad that 1.5-inch water pipe was 80% blocked. It was clogged to the point

that there was only $\frac{1}{2}$ inch diameter of flow area. The open pipe flow was 100 gpm. The clogged pipe flow was 20 gpm.

They tried cleaning the pipe mechanically and chemically. Neither approach lasted very long. The entire pipe was replaced with a copper pipe, and a **Triangular Wave System** was installed. The unit has been installed for about 1 year. They have not cleaned the pipe since the installation.

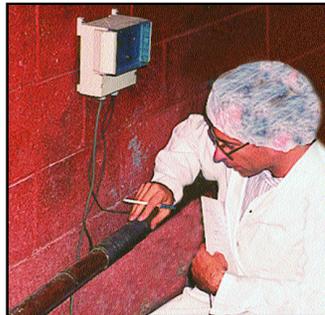
Technician Inspects Triangular Wave Coil and Power Supply

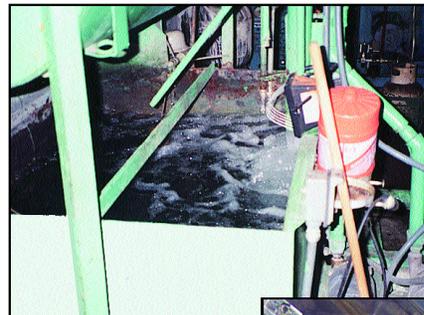
Cooling Tower and Water Holding Tank (shown here) Old Scale Detached from the Tower

One unit serves the water for the entire plant. Not only is the scale reduced in the pipes, but also they are finding scale in the return tank of the cooling tower. That is old scale that has detached from the cooling tower.
